United States Nuclear Regulatory Commission Official Hearing Exhibit	
In the Matter of:	Entergy Nuclear Operations, Inc. (Indian Point Nuclear Generating Units 2 and 3)

PWR REACTOR VESSEL ALLOY 600 ISSUES

Jeff Gorman, Steve Hunt, Pete Riccardella, and Glenn A. White

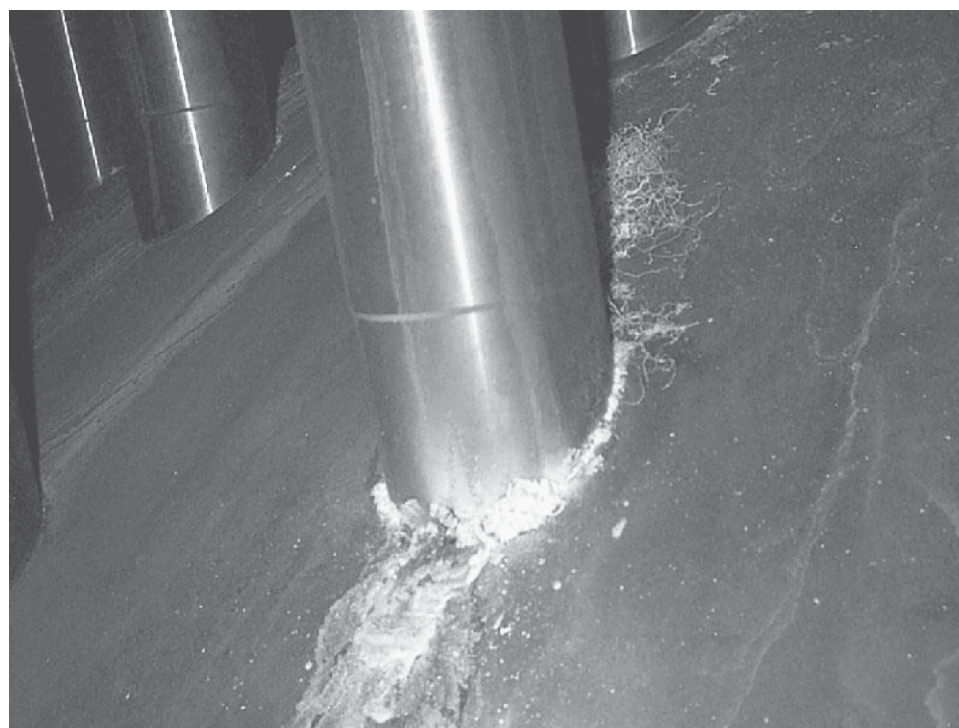
FIG. 44.8 TYPICAL SMALL VOLUME OF LEAKAGE FROM CRDM NOZZLE

Subsequent to the initial detection of PWSCC in a CRDM nozzle in 1991, increasing numbers of plants detected similar types of PWSCC, typically resulting in small volumes of leakage and boric acid deposits on the head surface as shown in Fig. 44.8. In 2000, circumferential cracks were detected on the outside diameter of some CRDM nozzles. In 2002, significant wastage of the low-alloy steel Davis-Besse reactor vessel head occurred adjacent to an axial PWSCC crack in an alloy 600 CRDM nozzle. The wastage was attributed to corrosion by boric acid in the leaking primary coolant that concentrated on the vessel head. Figure 44.9 shows a photograph of the corroded surface at Davis-Besse. The Davis-Besse plant was shut down for approximately 2 years for installation of a new head and incorporation of changes to preclude similar corrosion in the future. The NRC issued several bulletins describing these events and requiring utilities to document their inspection plans for this type of cracking [34–36].

Bare metal visual inspections have proven to be an effective way of detecting very small leaks, as shown by Figs. 44.8 and 44.11, and, therefore, should play an important role in any inspection program. A key prerequisite for these inspections is that the surface should be free of preexisting boric acid deposits from other sources, because the presence of preexisting boric acid deposits can mask the small volumes of deposits shown in Figs. 44.8 and 44.11. Visual inspections with insulation in place can provide a useful backup to bare metal visual inspections but will be incapable of detecting small volumes of leakage, as shown in Figs. 44.8 and 44.11.

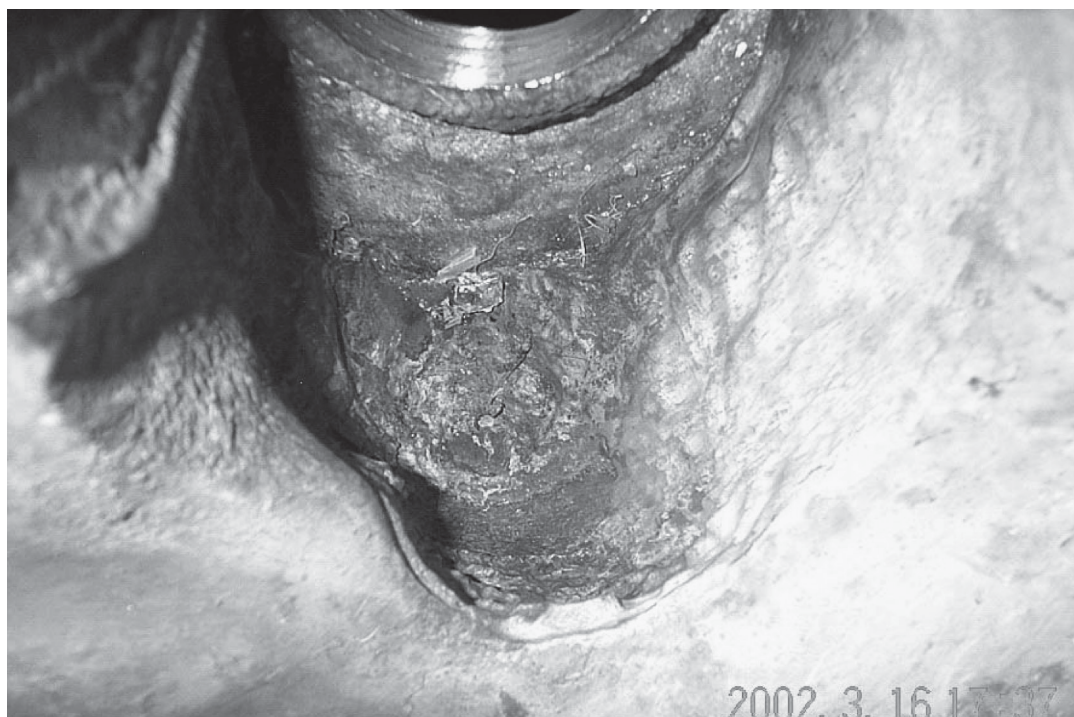
FIG. 44.9 LARGE VOLUME OF WASTAGE ON DAVIS-BESSE REACTOR VESSEL HEAD

As evidenced by the significant volume of material corroded from the Davis-Besse reactor vessel head, boric acid corrosion has the potential to create significant safety risk. Figure 44.13 shows cross-section and plan views of the corroded region of the Davis-Besse head shown in Fig. 44.9. As indicated, a large volume of the low-alloy head material was corroded, leaving the stainless steel cladding on the inside of the vessel head to resist the internal pressure. Part-depth cracks were discovered in the unsupported section of cladding.

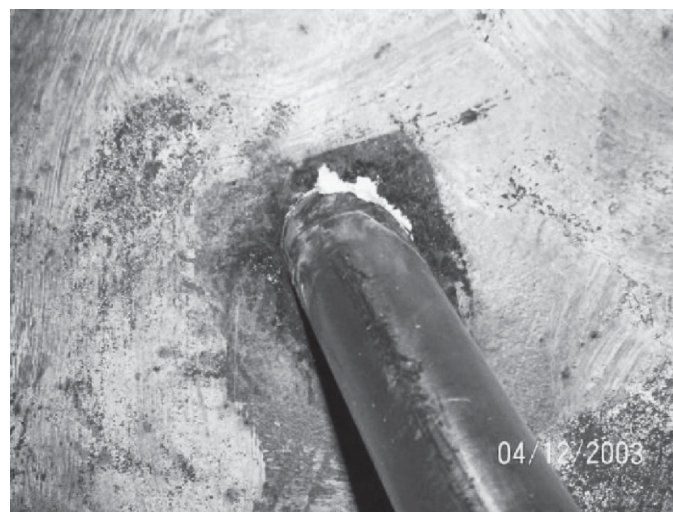
**FIG. 44.11 LEAK FROM SOUTH TEXAS 1 BMI NOZZLE**

In 2003, bare metal visual inspections of the reactor vessel bottom head at South Texas 1 showed small leaks from two BMI nozzles, as shown in Fig. 44.11. These leaks were traced to PWSCC cracks in the nozzles that initiated at small regions of lack-of-fusion in the J-groove welds between the nozzles and vessel head [38]. The nozzles were repaired. Examinations of the other BMI nozzles at South Texas 1 showed no additional cracks. Essentially all other U.S. plants have performed bare metal visual inspections of RPV bottom-head nozzles without any evidence of leaks. At least a dozen U.S. plants have completed volumetric examinations of the BMI nozzles, representing more than 20% of the total population of RPV bottom-head nozzles in the U.S., with no reported cracking. Similarly, no indications of in-service degradation have been identified in volumetric inspections of RPV bottom-head nozzles performed in other countries. PWSCC of BMI nozzles that operate at the plant cold-leg temperature is generally considered to be less likely than PWSCC at locations operating at hot-leg or pressurizer temperatures. The earlier-than-expected

PWSCC in BMI nozzles at South Texas 1 may be related to a combination of high material susceptibility and welding flaws.
